**NBSIR 76-1159**

# **Fatigue and Weatherability Studies of Aramid-Fiber Rope Slings**

Nixon Halsey  
Leonard Mordfin

September 1976

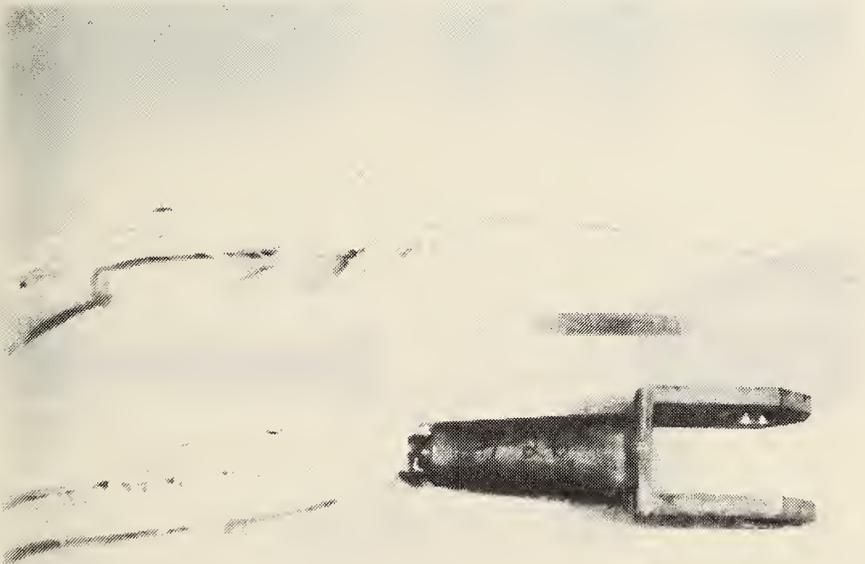
Figure 4. High-capacity sling-leg specimens after test. These specimens were fabricated from cabled-strand ropes with braided polyester jackets.

(a), above: Specimen No. 25 with free-length failure incurred in fatigue.

(b), below: Specimen No. 26 with failure adjacent to experimental end fitting, incurred in tension test following fatigue loading.

Of the five cabled-strand specimens which were tested, three, representing one of each tensile capacity, survived without failure. A fourth, of medium-capacity, suffered a partial failure (Figure 3), but nevertheless survived the entire test. The fifth, a high-capacity specimen, failed in its free length relatively early in the test (Figure 4a).

d. Specimen failed in free length (Fig. 4a).

The results of the tests are given in Table 9. Of the seven specimens tested, two failed in their free lengths at loads substantially below their rated breaking loads. One of these, Specimen No. 17 (Table 8) had experienced a failure of one of its strands in its fatigue test, and the other, Specimen No. 8 (Table 6), probably sustained shock-loading damage in the recoil from the fatigue failure of its end fitting. The other five specimens all failed in or near an end fitting. The breaking loads for four of these specimens closely approached, or exceeded, the respective rated breaking loads. The fifth, Specimen No. 26, a high-capacity cabled-strand specimen, failed at only 78 percent of its rated breaking load. The failure occurred adjacent to both of its end fittings despite the fact that there had been no seepage of potting compound from the fittings. See Figure 4b.

- a. Specimen failed near end fitting where potting compound had seeped into free length.
- b. Not measured.
- c. Specimen had sustained previous damage (see Section 4.3) and failed in free length.
- d. Specimen failed inside one end fitting.
- e. Specimen failed by pulling out of one end fitting.
- f. Specimen failed adjacent to both end fittings (see Figure 4b). Potting compound had not seeped out of the fittings.

specimen, referred to above, which had survived the fatigue spectrum. In its subsequent tensile test, this specimen (No. 26, Table 9) failed at an end fitting at only 78 percent of its rated breaking load.
